TEXAS NATURAL RESOURCE CONSERVATION COMMISSION
WATER QUANTITY DIVISION
CONSTRUCTION PROGRESS REPORT

INVENTORY NO. TX-3757 WATER RIGHT AUTHORIZATION A-2302 / P-2076

DAM Lake Galahad Dam

EVALUATION DATE May 6, 1997

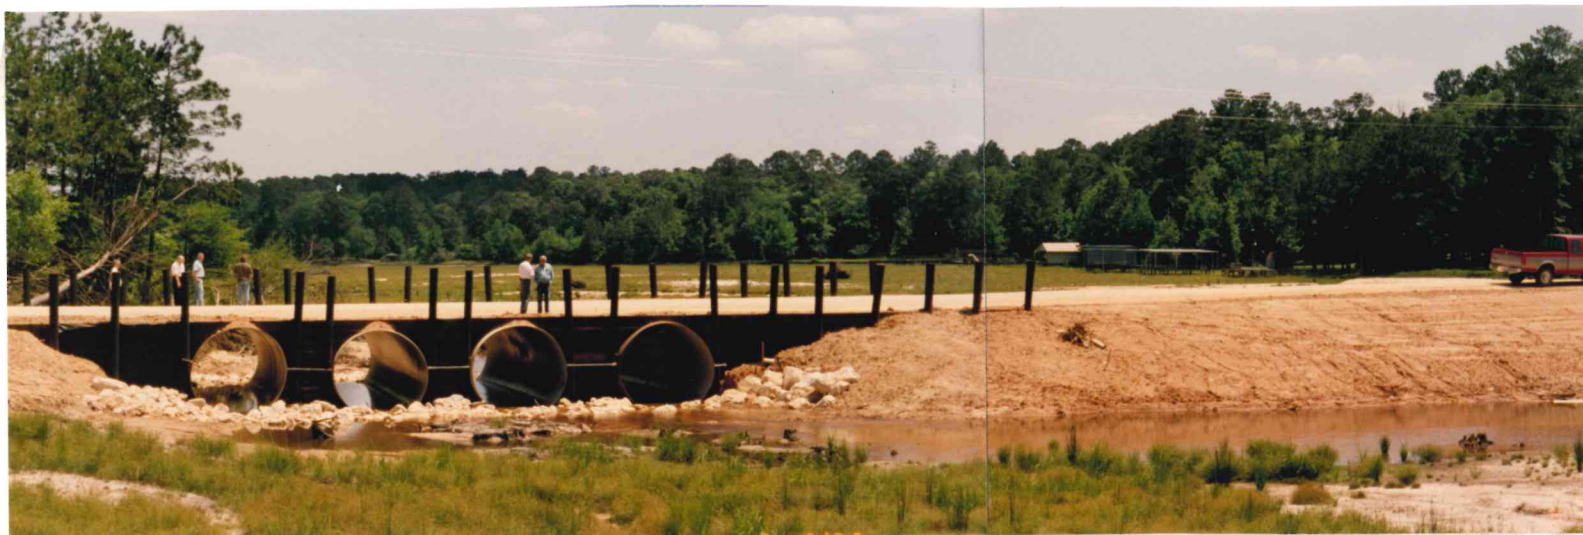
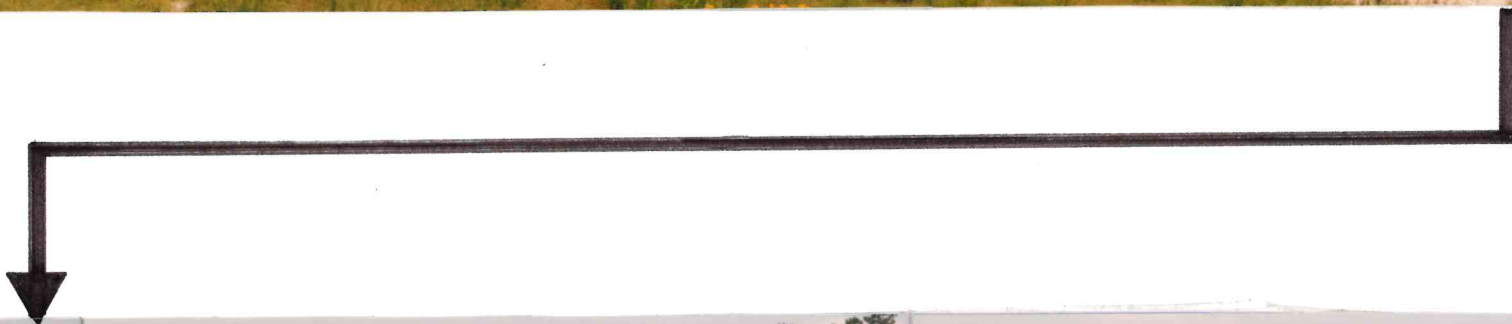
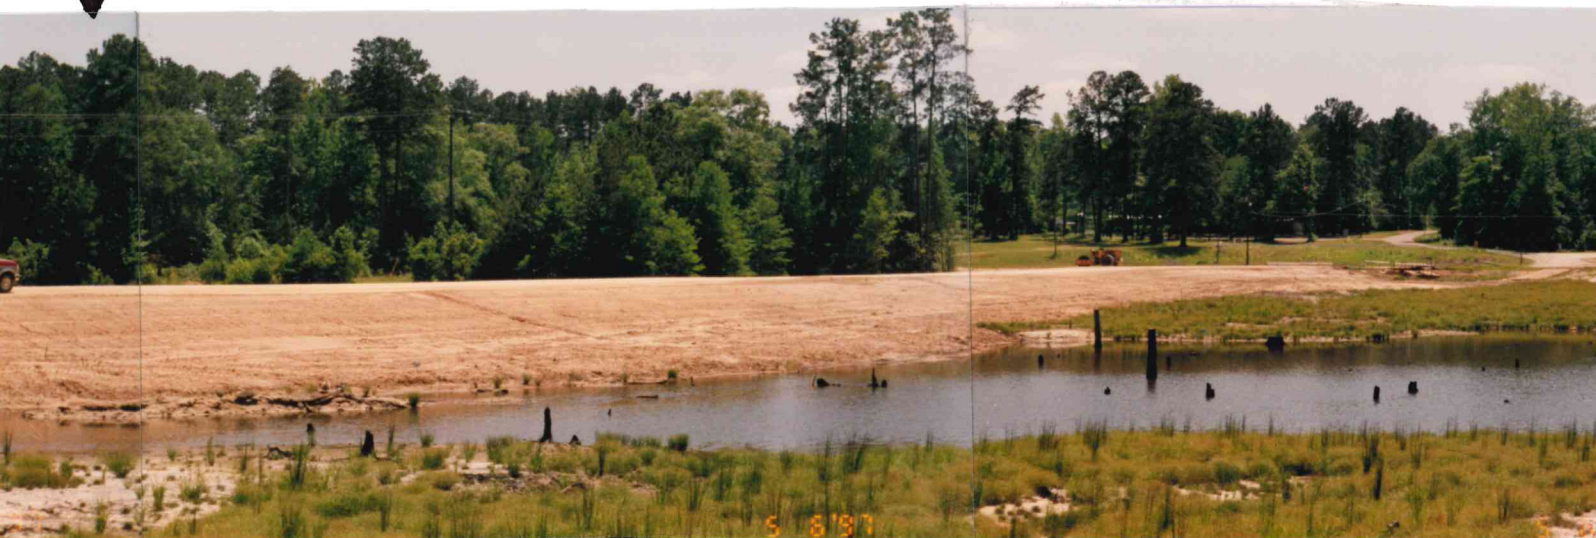
Photo No.1: This panoramic view of the dam shows that the dam has been modified to act as a low water crossing. The main embankment has been lowered by approximately 5-feet. The main embankment will be lower than the old emergency spillway crest. The section of the embankment over the culverts will be approximately 2.5-feet lower than the main embankment. Note the telephone poles that were used to anchor the culverts.

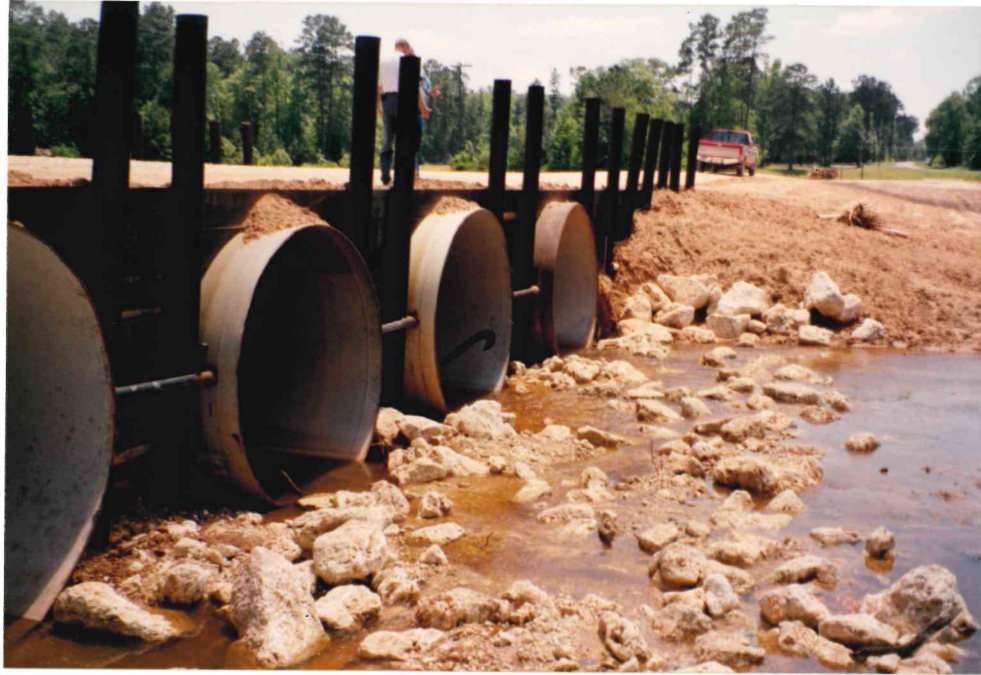
Photo No.2: This closeup of the culverts shows the large rock that has been placed near the inlet to help reduce the effects of erosion. Note the creosoted timber head wall and telephone pole anchoring. Each culvert has been tied together with welded pipes.

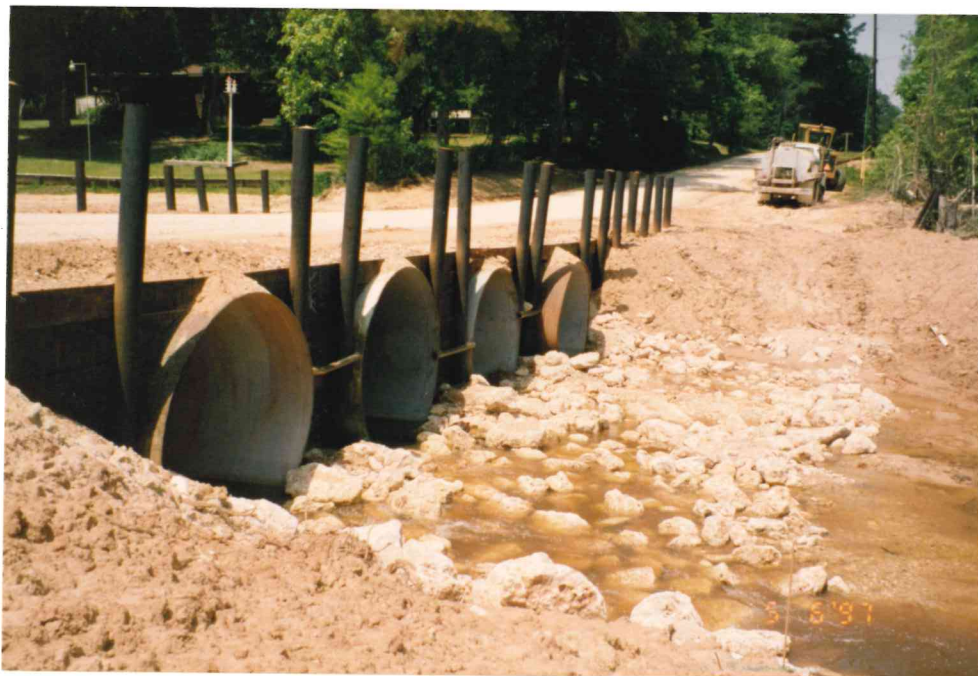
Photo No.3: The downstream discharge outlet for the culverts appears to be identical to the upstream inlet area.
Lake Galahad Dam
TX-3757

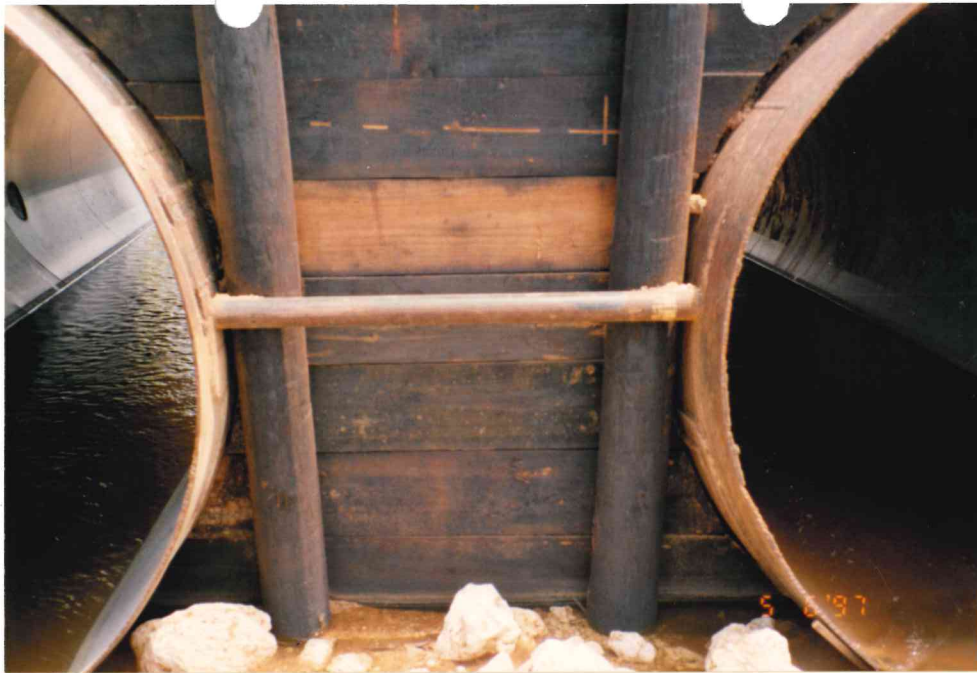
Photo No.4: A closeup of the head wall and anchoring system which was used for the culverts. Note the welded pipe that attaches to each culvert.

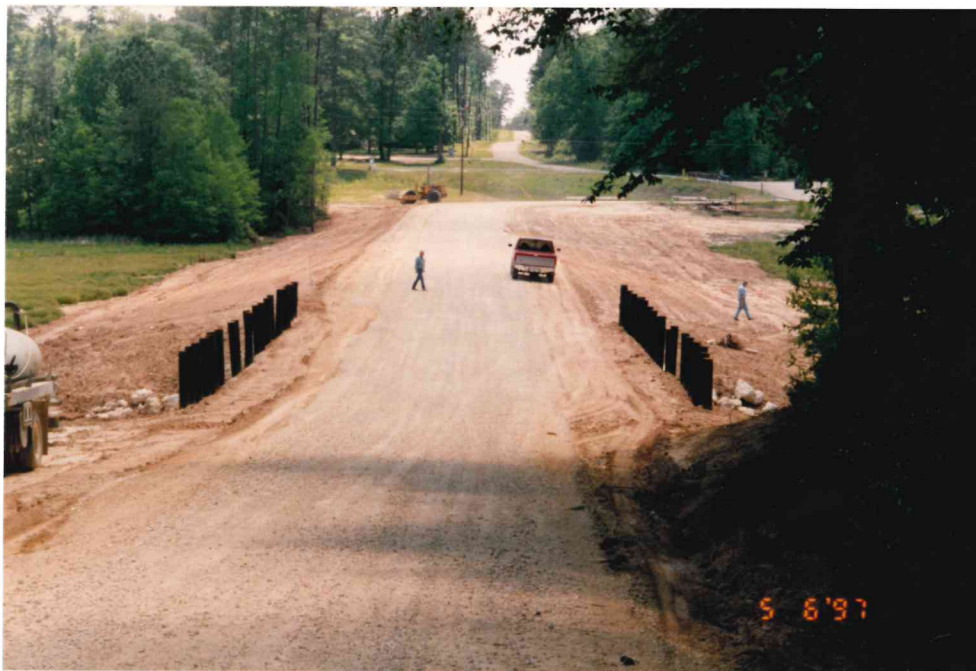
Photo No.5: View of the crest of the modified dam as seen from the left abutment. Note the flat slopes. The blacktop road way has not yet been applied.
